2018 GM IOB Update

All 2018 GM vehicles require an update.

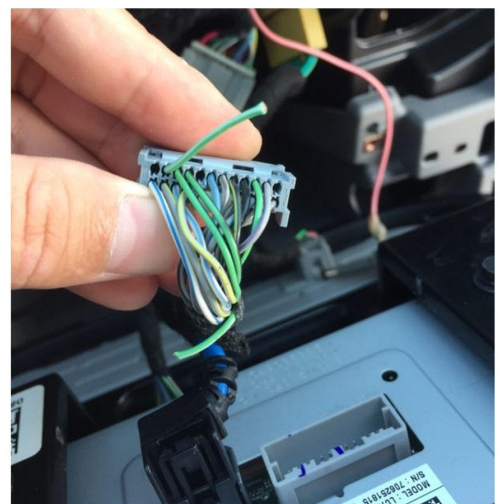
In order for the interface to work properly on vehicles equipped with the factory rear view camera, in addition to updating the interface, you have to cut the green/white wire pin 2 in the grey plug found in the rear of the factory display.

NOTE: Cut the wire back far enough in-case you need to re-connect at a later date. Tape both sides of the wire after cutting.
